Fault diagnosis and remedies – DISCS

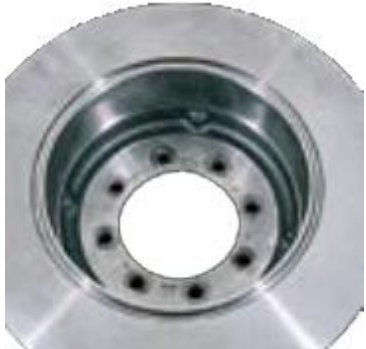
Appearance:	The contact point on the hub is cracked around the fitment holes or the surface is distorted

<p>Hub surface distortion</p>
Cause:	The correct sequence for tightening was not followed and not enough torque was used	
Effect:	Driver feels vibration as soon as new discs have been fitted	
Remedy:	Replace distorted or cracked discs and use the correct tightening sequence and torque settings advised by the vehicle manufacturer

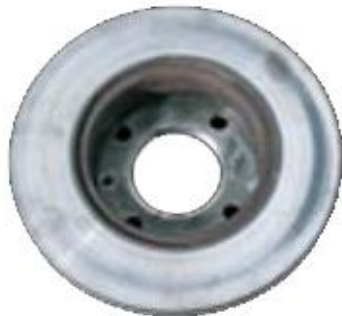
Appearance:	Discoloured spots on the disc surface, often blue in colour caused by overheating.

<p>Blue discs</p>
Cause:	Excessive hub run-out (> 0.03mm). When the disc to pad contact is uneven, it will cause	
Effect:	Vibration and noise that will increase if not dealt with	
Remedy:	Correct the wheel hub run-out to <0.03mm before fitting a new disc

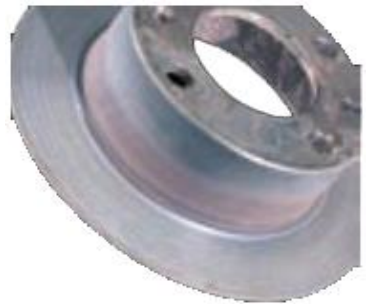
Appearance:	Grooves on the surface of the worn disc

<p>Surface grooves</p>
Cause:	Brake pads allowed to wear down to the back plate will score the disc as it is metal touching metal and ruin the disc surface	
Effect:	Poor performance and efficiency and a noisy “grind” of metal on metal	
Remedy:	Replace the discs and pads. If a wear indicator is in place, check the circuit is working properly

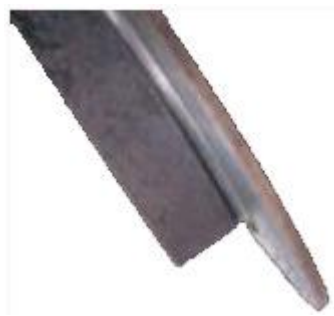
Appearance:	Grooves formed between the hat and disc surface

<p>Grooves between the hat and disc</p>
Cause:	The back plate of a very worn brake pad may be loose in the caliper and come into contact with the hat.	
Effect:	Poor braking performance and efficiency and noise from the metal on metal	
Remedy:	Replace discs and pads. Check and, if necessary, repair the caliper

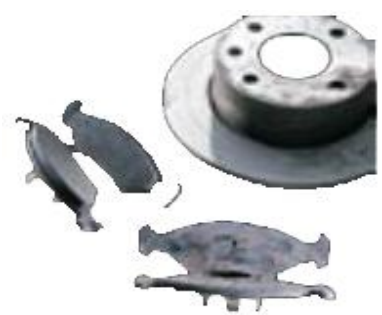
Appearance:	Friction wear that is more pronounced on one pad compared to the other

<p>Uneven pad wear</p>
Cause:	A seized caliper, forcing one pad to be touching the disc constantly – causing increased wear of one pad compared to the other. Scoring of the disc can occur if the material has worn down to the metal back plate	
Effect:	Poor braking performance and a constant grinding noise as the plate scores the disc. Vehicle may pull to one side under braking due to the imbalance.	
Remedy:	Check and replace or repair the caliper if necessary. Replace the discs and pads.

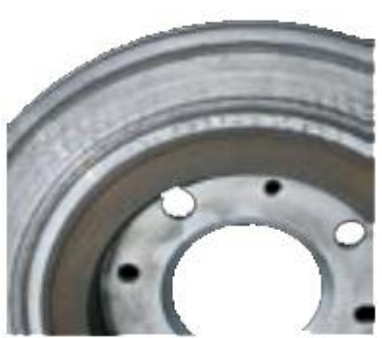
Appearance:	Grooving on the disc friction surface material

<p>Grooved disc</p>
Cause:	Deep grooves are caused by foreign objects and dirt coming in between the pad and disc and the particles being forced into the disc under braking.	
Effect:	Lower braking efficiency due to a reduced contact surface and noise during braking.	
Remedy:	Replace pads and discs

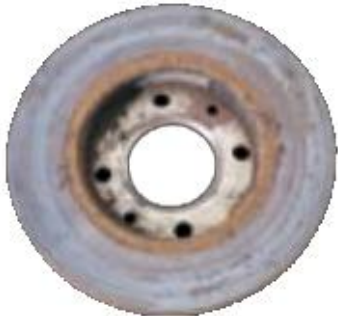
Appearance:	Glazing and dark spots on the disc surface

<p>Contamination of disc surface</p>
Cause:	Material from the brake pads have deposited onto the disc surface – generally from low-cost pads that have not been mixed and cured correctly.	
Effect:	Poor braking performance, a stiff pedal feel and vibration	
Remedy:	Installing good quality brake pads from a reputable manufacturer

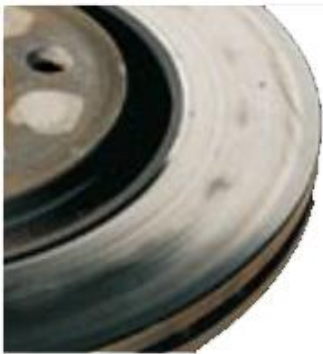
Appearance:	No longer a smooth surface of the disc. Blue spots and possible cracks on the friction surface of the disc

<p>Uneven wear, cracks and blue spots</p>
Cause:	Assembly issues. The caliper or pad being in the wrong place will cause uneven wear and hot spots (blue spots) when the pad is constantly in contact with the disc	
Effect:	The hot spots will slowly cause vibrations and a poorer braking performance	
Remedy:	Check and, if necessary, repair the caliper. Replace pads, checking type and shape are correct for application and if the pads are handed

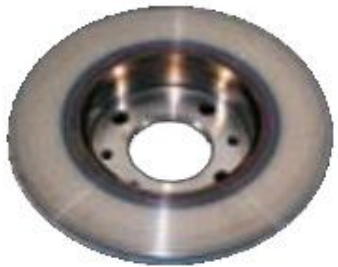
Appearance:	Colours on the friction surface of the disc (various shades of violet, blue or gold)

<p>Coloured discs</p>
Cause:	Not following correct bedding in procedure. Newly fitted discs can have slight variations on the friction surface. If the discs aren't carefully bedded in, a metallurgical change will occur on the friction surface, causing the discolouration	
Effect:	Reduced braking performance due to decreased friction. Vibrations can happen and become worse over the life of the disc.	
Remedy:	Replace the discs and adhere to the correct bedding in procedure of gentle braking (no heavy braking) for the first 200 to 300 miles.

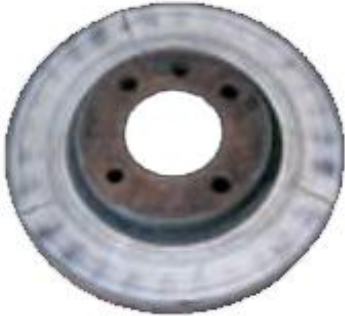
Appearance:	Radial fractures or blue spots in line with the venting frames

<p>Fractures / spots on surface material</p>
Cause:	The spots are the result of rising cracks, caused from a metallurgical change in the friction material which makes it stiff and brittle. Overloading the car, an aggressive driving style or intensive use could cause this.	
Effect:	Poor braking performance, noise, vibrations and brake fade	
Remedy:	Replace the discs and after correctly bedding in the new discs avoid aggressive driving and use the engine to reduce speed as well as the brake system

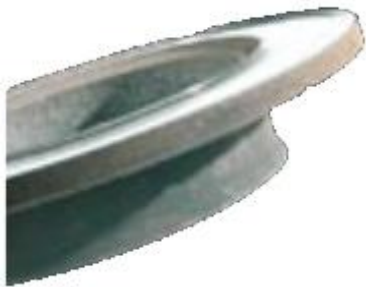
Appearance:	Extensive wear. Disc thickness lower than the recommended minimum thickness

<p>Worn discs</p>
Cause:	Discs not checked regularly and not replaced at appropriate time	
Effect:	Reduced performance vibration and noise while braking. Dangerous to drive	
Remedy:	Full inspection of braking system and associated components. Replace any failed components and fit new discs observing manufacturer's recommended torque and sequence during tightening. Maintain regular checks of the pads and discs

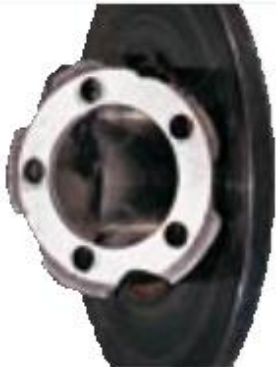
Appearance:	Hub contact surface is detached from the main disc or distorted

<p>Detached hub</p>
Cause:	Over tightening when mounting discs. Failure to adhere to correct torque settings	
Effect:	Detachment of disc friction surface. Complete brake failure and very dangerous to drive	
Remedy:	Complete inspection of braking system and associated components. Replace any failed components. Replace discs observing correct torque settings and sequence

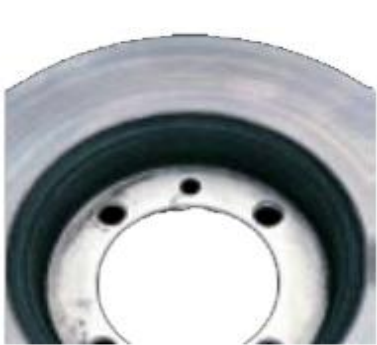
Appearance:	Distorted hub contact surface and/or cracks

<p style="text-align: center;">Distorted hub</p>
Cause:	Over tightening the positioning screw	
Effect:	Vibration under braking that will get progressively worse	
Remedy:	Replace discs and follow correct torque settings. Do not over tighten positioning screw

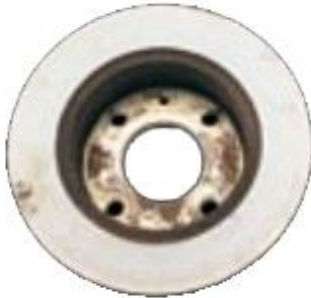
Appearance:	Dirty marks and/or rust on hub surface

<p style="text-align: center;">Dirt and rust on hub</p>
Cause:	Improper cleaning of the hub leading to contamination, misalignment and DTV	
Effect:	Disc Thickness Variation, pads not touching the discs evenly and resulting in noisy and vibrating brakes which will get progressively worse	
Remedy:	Meticulously and carefully clean the hub surfaces, eliminating all rust and other debris. Check the run out and replace if hub has been damaged. Replace discs following correct torque settings and checking for run out

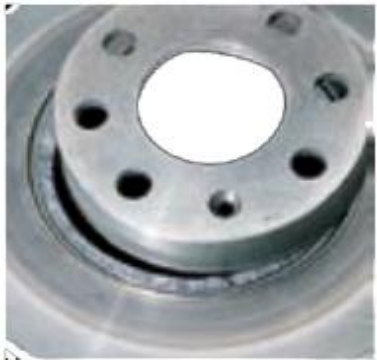
Appearance:	Detachment of the disc hat from the braking surface

<p style="text-align: center;">Detachment of the hat</p>
Cause:	Stress due to incorrect assembly or positioning of the caliper. Results in uneven wear of the surface causing detachment	
Effect:	Loud noise under braking and vibrations. Total brake failure after detachment	
Remedy:	Full inspection of braking system and associated components. Replace failed components and replace discs, carefully following correct torque settings and sequence. Check caliper is working well before fitting pads.
