Impulse rings and wheel bearings

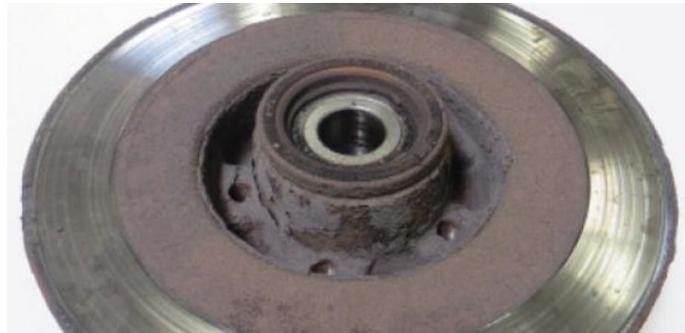
If the impulse ring has been damaged, the ABS light will illuminate, an error code is stored in the diagnostics and the ABS will be inoperative. The following are the most common causes of failure of the impulse ring.

**Cause:**

Contamination by environmental influences (e.g. water, salt and dirt)

**Effect:**

Rust accumulation on the surfaces of the toothed segments can damage the ring gear, thus leading to incorrect speed information from the wheel speed sensor.

Cause:

Incorrect installation due to improper use of tools (hammer, screwdriver, etc.)

Incorrectly applied installation forces can damage the bearing or impulse ring

Excessive use of lubricants

Too much lubricant leads to an accumulation of dirt and abrasion

Use of metallic-based lubricants (e.g. copper paste)

The metallic particles contained can chemically react with water and salt, thereby increasing oxidation levels and causing sensor failure and system malfunctions.

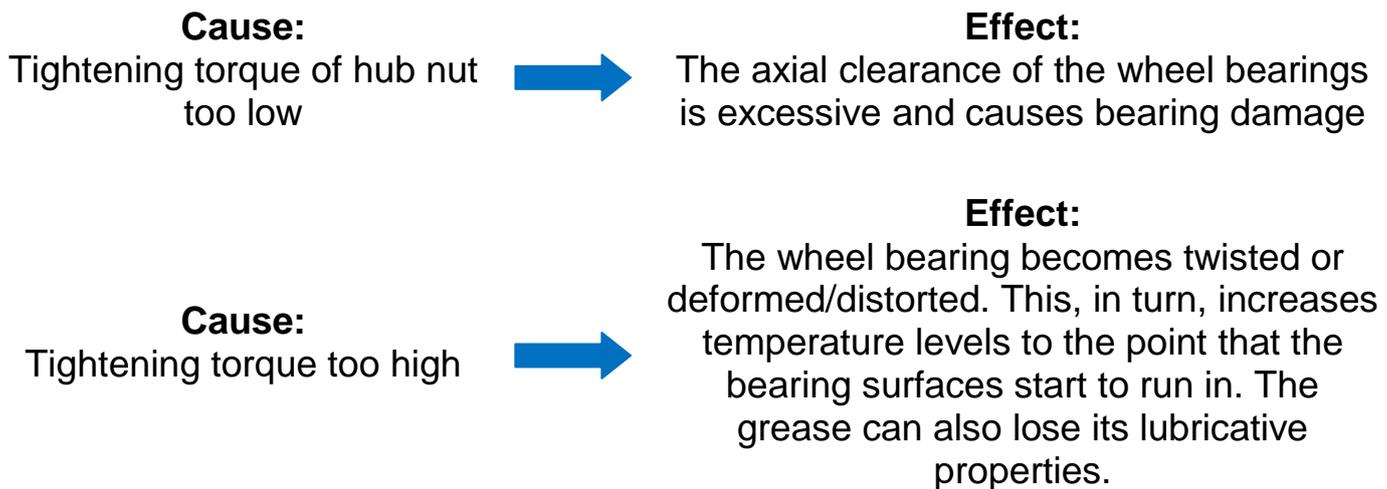
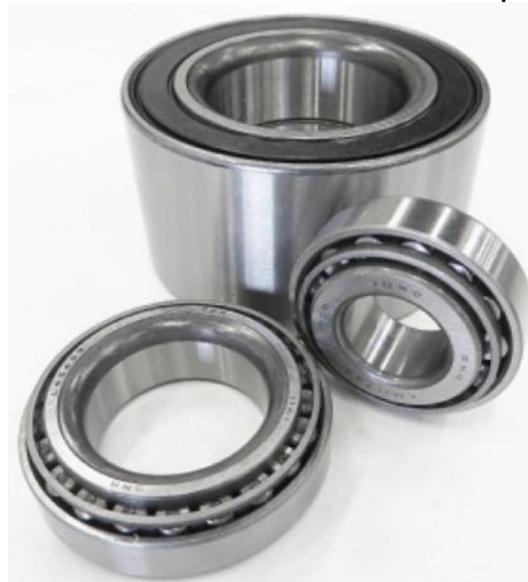
If there is axial clearance of the wheel, droning or grinding running noises is a sure sign that damage has occurred to the wheel bearing and it needs to be replaced. The following are the most causes and effects for problems with wheel bearings.
